The response of metal-matrix composites subjected to quasi-static and shock-wave deformation

J. C. Huang and Y.-S. Lo

Abstract

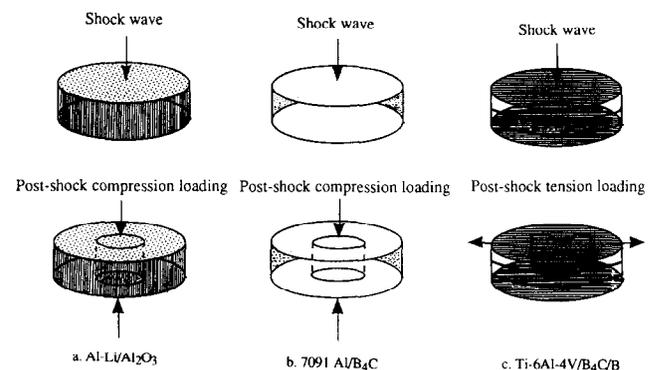
Fig. 1. Schematic illustration of the orientations of the shock-loading and post-shock reload tests for the three composites.

$4/3[\ln(v/v_0)]$, where v and v_0 are the shock-compressed and initial volume of the sample, was calculated to be ≈ 7 –9% for all three metal-matrix composites. The true strain in the reinforcing ceramics is currently impossible to calculate, owing to the lack of sufficient Hugoniot data and composite wave mechanics. All the recovered composites were flat and possessed measured residual strains of 1–2%, typical of a well-momentum-trapped shock assembly [4]. One-half of each shock-loaded specimen was cut into slices from which samples for transmission electron microscopy (TEM) were prepared. Small cylindrical compression or flat tensile specimens for post-shock reload stress-strain measurements were electron-discharge machined (EDM) from the remaining half (Fig. 1).

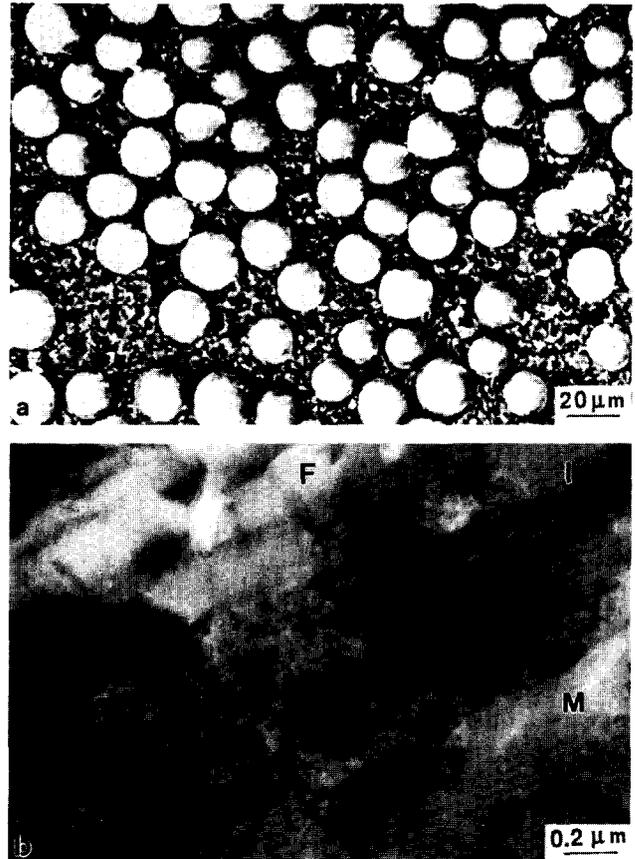
Fig. 2. (a) SEM micrograph of the polished and etched microstructure, and (b) TEM micrograph of the interface region in the Al-Li/Al₂O₃ composite. The fiber, interface and matrix are marked F, I and M, respectively.

Al-Li/Al₂O₃(ϕ). A typical SEM micrograph of the AR Al-Li/Al₂O₃ composite is shown in Fig. 2(a). Fibers are seen to be randomly distributed in the matrix. It can be seen that there is an interaction zone between the reinforcement and the matrix. Significant fiber-matrix reaction occurs during fabrication by the liquid metal vacuum infiltration process, and this result is consistent with that seen by Majidi and Chou [10]. The reaction zone was observed to be approximately 2 μm thick in the as-received condition, and there were no precipitates or inclusions at the interface, as shown in Fig. 2(b). Intrinsic defects (pores) within the Al₂O₃ fibers were also seen. These are postulated to affect the failure behavior of the composite. Analysis of diffraction patterns from the Al-Li matrix region indicated that the metastable δ' (Al₃Li) phase was not present. It appears that most of the Li atoms have contributed to the formation of fiber/matrix interfacial reaction products and thus did not simultaneously allow the nucleation of the δ' phase.

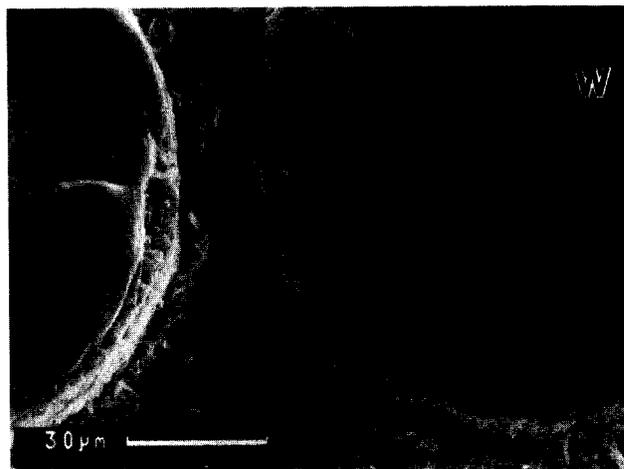
Fig. 4. SEM micrograph of the cross-sectional view of the AR Ti-6Al-4V/B₄C/B composite; interfacial reaction products can clearly be seen.

Ti-6Al-4V/B₄C/B₀. Figure 4 shows a SEM cross-sectional view of the Ti-6Al-4V/B₄C/B as-received sample. The small inner core of the fiber is the W wire, which was used as a seed for the B and B₄C deposition. Outside the original 6 μ m-thick B₄C coating a TiB₂ continuous layer varying in thickness from 1 to 3 μ m can be seen. The outer needlelike phase has been

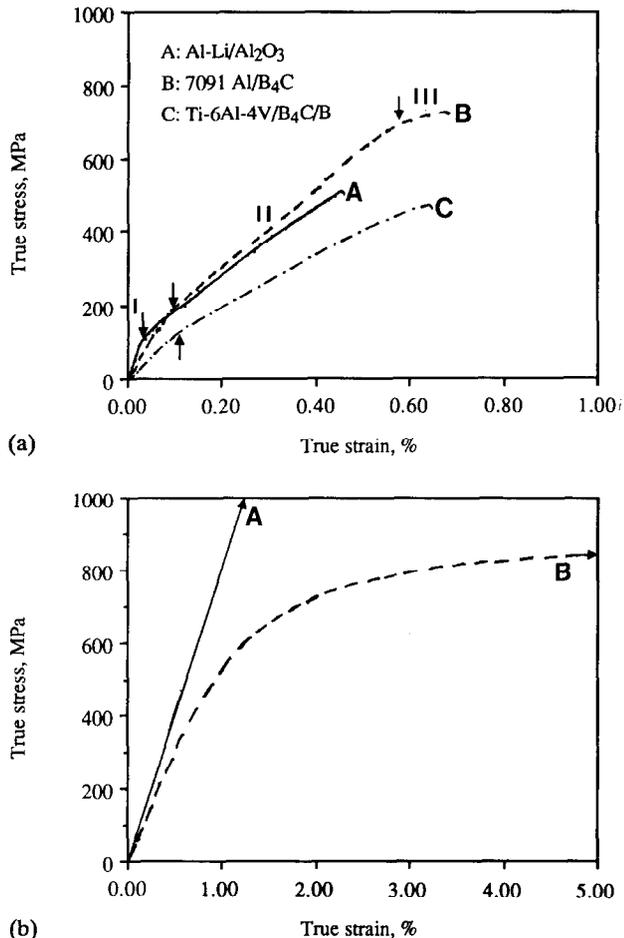
Fig. 5. Typical true stress-strain curves of the three composites tested under quasi-static conditions: (a) tension, (b) compression. The average failure stress and strain for the Al-Li and 7091 base composites under compression loading are 1500 GPa and 2.3%, and 870 GPa and 15%, respectively. The compression test on the Ti composite was not performed owing to its thin sheet nature.

Typical stress-strain curves for the Al-Li/Al₂O₃, 7091Al/B₄C and Ti-6Al-4V/B₄C/B composites in quasi-static tension and/or compression are shown in Fig. 5. For the Al-Li/Al₂O₃ and Ti-6Al-4V/B₄C/B composites, the tensile curves are seen to exhibit two distinct regions. In the initial region, the stress increases linearly with strain. Upon additional loading, the stress-strain curves deviate from linearity in stage II, which is postulated to be due to the fiber cracking normal to the applied load. The quasi-static fracture mechanism should be related to the intrinsic fiber defects (pores) in the Al-Li composite and the degraded fiber surface due to interfacial reaction in the Ti-base composite. The 7091Al/B₄C composite stress-strain response also possesses three distinct regions. Observations of the fracture surface suggest that the fracture process was controlled by void formation in the matrix close to the matrix/particle interface and these voids linked by microvoid coalescence in the matrix between the B₄C particles, thus leading to final failure.

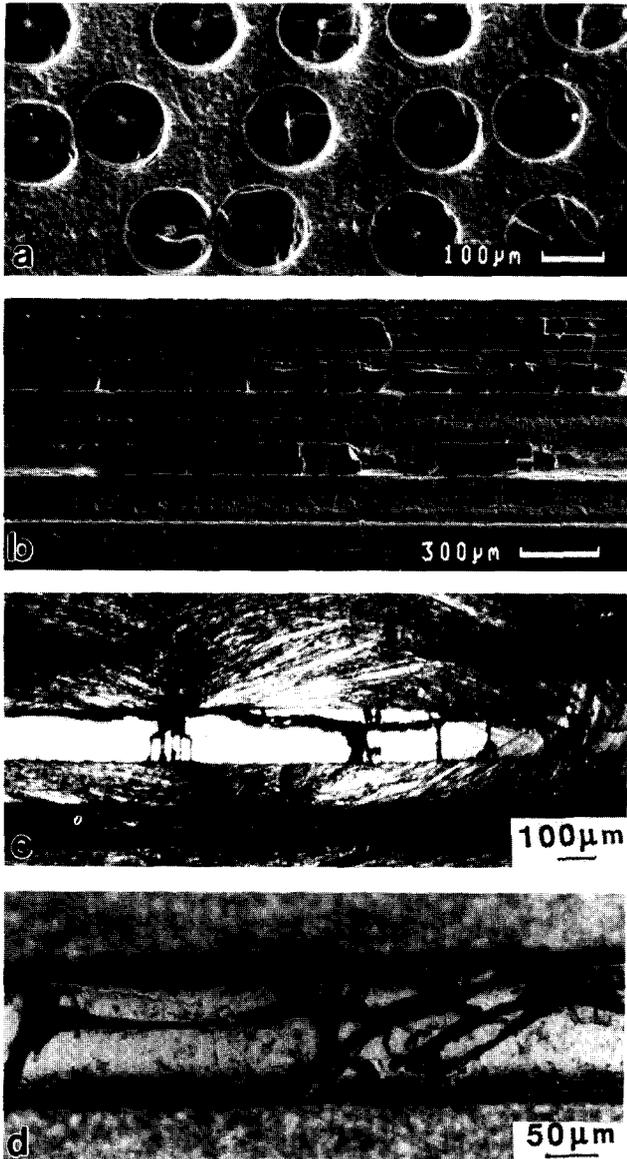
Fig. 8. Optical or SEM micrographs of the cross-sectional (a) and longitudinal (b)–(d) views of the shock-loaded Ti-6Al-4V/ B_4C/B composite. Multiple cracking modes can be seen in (b)–(d). The incident shock wave direction is from top to bottom in these figures.

Optical and SEM observations of the Ti-6Al-4V/ B_4C/B composite materials revealed significant cracking of the fibers. The typical morphology of the shocked composite, seen from the cross-sectional and longitudinal directions, is shown in Fig. 8(a)-(d). Cracks were seen to propagate throughout the cross section of the composite. Crack branching was also observed (Fig. 8(c)). Fine branches are thought to correspond to crack initiation, with the branches converging into major cracks, similar to river patterns. The aspect ratio of the broken B_4C/B fibers after shock loading was about 4 to 5. Almost all of the fibers were seen to have microcracks that propagated across the fiber cross section. Some of the cracked fibers appeared to have spalled away from the surface during cutting.

When the shock wave loading was applied perpendicular to the fibers, the long fibers were observed to fail readily. Cracking within the fibers was found to be diverse, some of them having several branching cracks (see Fig. 8). The fine branches also indicate the site of crack initiation, which was usually at the bottom of the fiber (the side away from the incident shock wave, under tensile stress). It has been thought that the fiber breakage might have been resulted from the macroscopic sample bending. However, no evidence of any residual bulk bending was observed for this side-on shock loading. Nevertheless, it is believed that local bending stresses did occur during impact, owing to local material and thus stress distribution heterogeneity. Such local bending stresses will initiate the branching cracks. Once the fibers undergo branching cracking, the tendency for buck bending will be largely reduced. Meanwhile, the release wave may also play a significant role

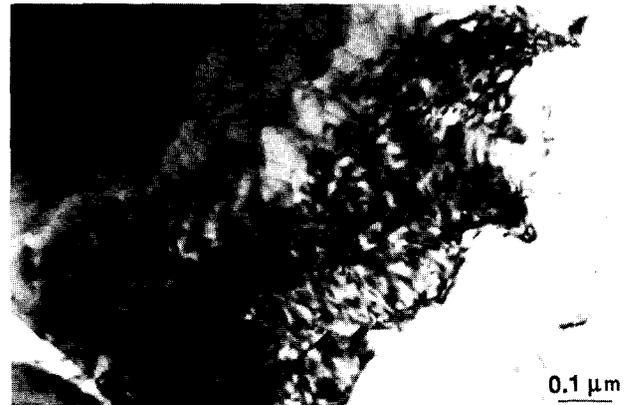
Fig. 9. TEM micrograph of the shock-loaded Al-Li/ Al_2O_3 composite, showing a high density of tangled dislocations in the matrix.

Al-Li/Al₂O₃. Figure 9 shows the substructure of the aluminum matrix in the Al-Li composite. A high density of tangled dislocations was observed in the matrix, especially near the fiber/matrix interface. The

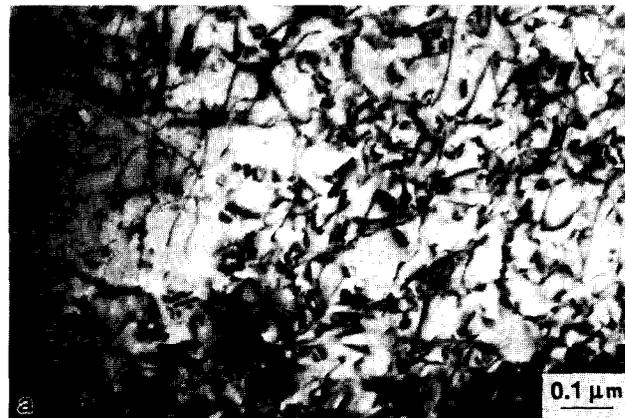
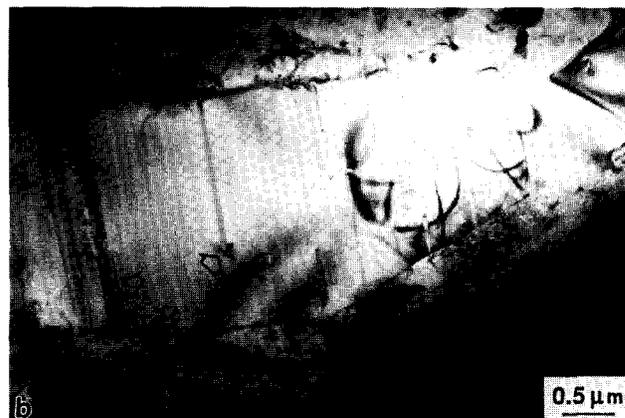
Fig. 10. TEM micrograph illustrating (a) tangled dislocations in the matrix and (b) deformation twins. The twins have been seen on $\{0001\}$ and/or $\{11\bar{2}0\}$ planes within the B_4C particles in the shock-loaded 7091 Al/ B_4C composite.

7091Al/B₄C_(p). A tangled dislocation morphology (Fig. 10(a)) similar to that seen in the Al-Li base composite was also observed in the 7091Al/B₄C composite matrix. The small η' precipitates did not seem to produce a pronounced effect on the dislocation morphology. The substructure of the B₄C particulates in the shock-loaded 7091Al/B₄C samples is presented in Fig. 10(b). Deformation twins, lying on {0001} and/or {1120} planes, were seen within the B₄C (hcp) particles exposed to shock-wave prestraining.

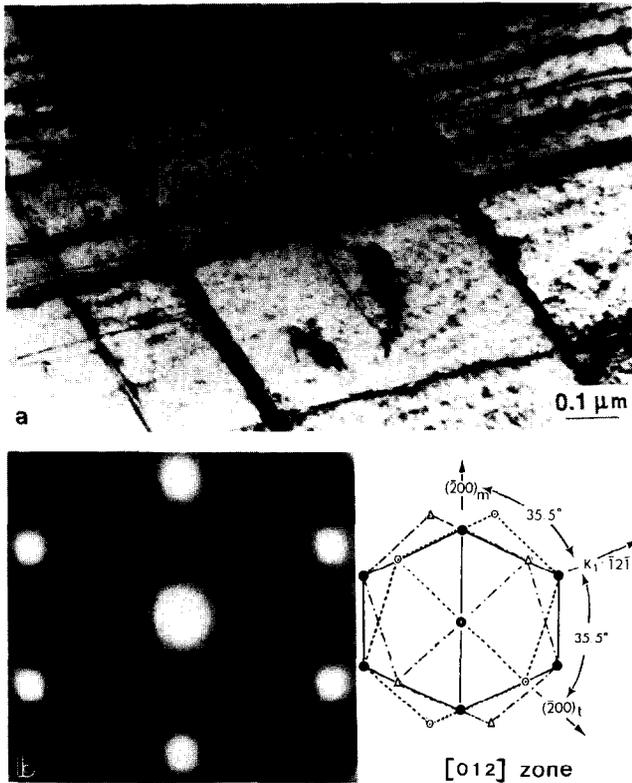
Fig. 11. (a) TEM micrograph showing two variants of planar slip bands, and (b) TEM diffraction pattern with weak twin reflections, both in β grains of the shock-loaded Ti-6Al-4V/B₄C/B composite.

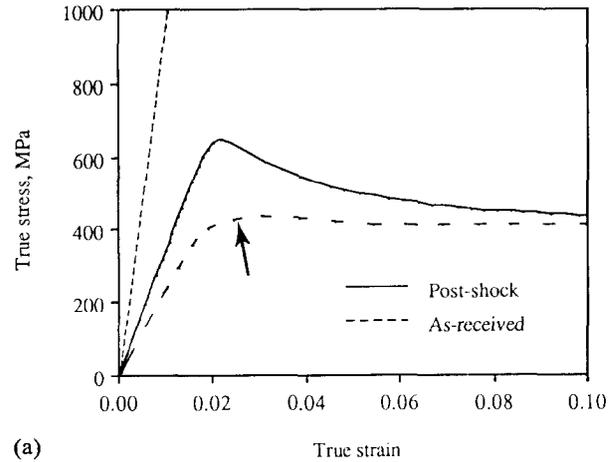
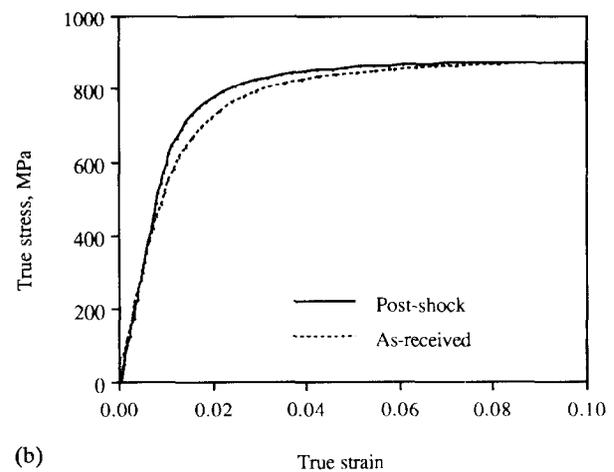
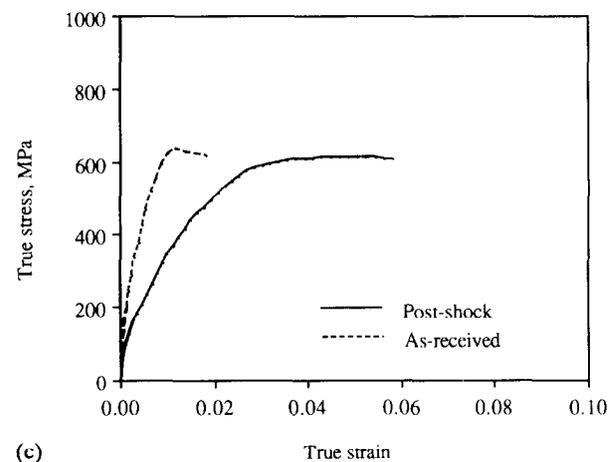
Fig. 12. True stress-strain curves of the post-shock reload tests for the three composites: (a) Al-Li/Al₂O₃ under compression; (b) 7091Al/B₄C under compression; (c) Ti-6Al-4V/B₄C/B under tension. The lower AR curve in (a), indicated with an arrow, was obtained when the compression sample was not properly aligned during loading.

3.3.1. Comparison of composite mechanical response
 Al-Li/ Al_2O_3 . The true stress-strain curves from a quasi-static compression test on the AR and SP Al-Li/ Al_2O_3 composites are given in Fig. 12(a). The typical

7091Al/B₄C_(p). Representative stress–strain curves obtained from compression tests on the AR and SP 7091Al/B₄C composites are shown in Fig. 12(b). The maximum compressive flow stress of both specimens reached ≈ 870 MPa at 10% strain, and this strength was maintained until failure (14–18%). The strength of the AR and SP particulate-reinforced specimens did not appear to be appreciably different. This was also true for the elastic modulus – both were ≈ 60 GPa for the tiny compressive samples. Shock loading was not seen to cause any significant effect on the mechanical properties of the 7091Al/B₄C composite, and it is postulated that this is related to the fact that the damage induced in the B₄C particles and at the matrix/particle interfaces by shock-prestraining was not sufficient to significantly alter the flow stress. However, dislocation generation and storage in the 7091Al matrix during shock loading yielded a slight increase in the reload yield strength of the composite. If the reload test had been conducted in tension, a certain degree of strength degradation might have been expected.

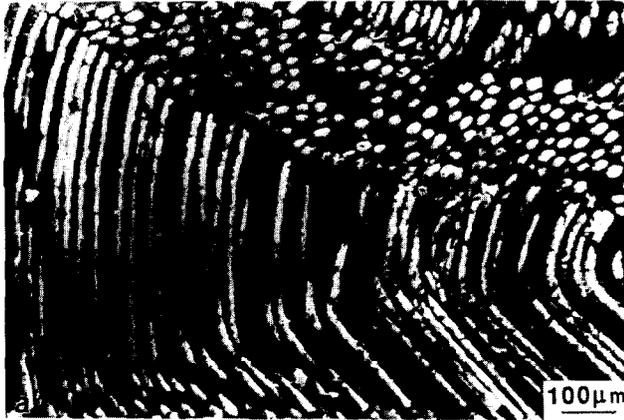
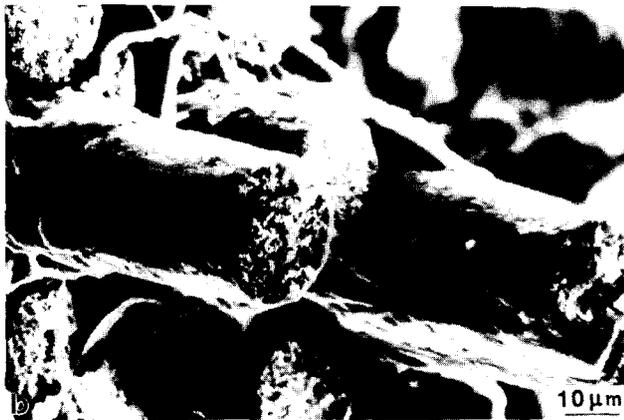
Fig. 13. (a) Optical micrograph showing the kinking effect; (b) SEM micrograph showing fiber pullout and interface failure in the AR Al-Li/Al₂O₃ composite tested at a low rate.

Following quasi-static tensile deformation, the AR Al–Li/Al₂O₃ composites (larger samples) exhibited a highly ductile matrix. Figure 13(b) shows evidence of fiber pullout and interface failure. Examination of the fracture surface at a higher magnification showed failure at the fiber matrix interface and also the formation of voids at the interface. The resultant tensile fracture surface of the AR Al–Li/Al₂O₃ composites is, however, macroscopically planar, compared with the fracture surfaces of the AR Ti composites and the AR Al–Li/Al₂O₃ composites under Charpy impact fracture.

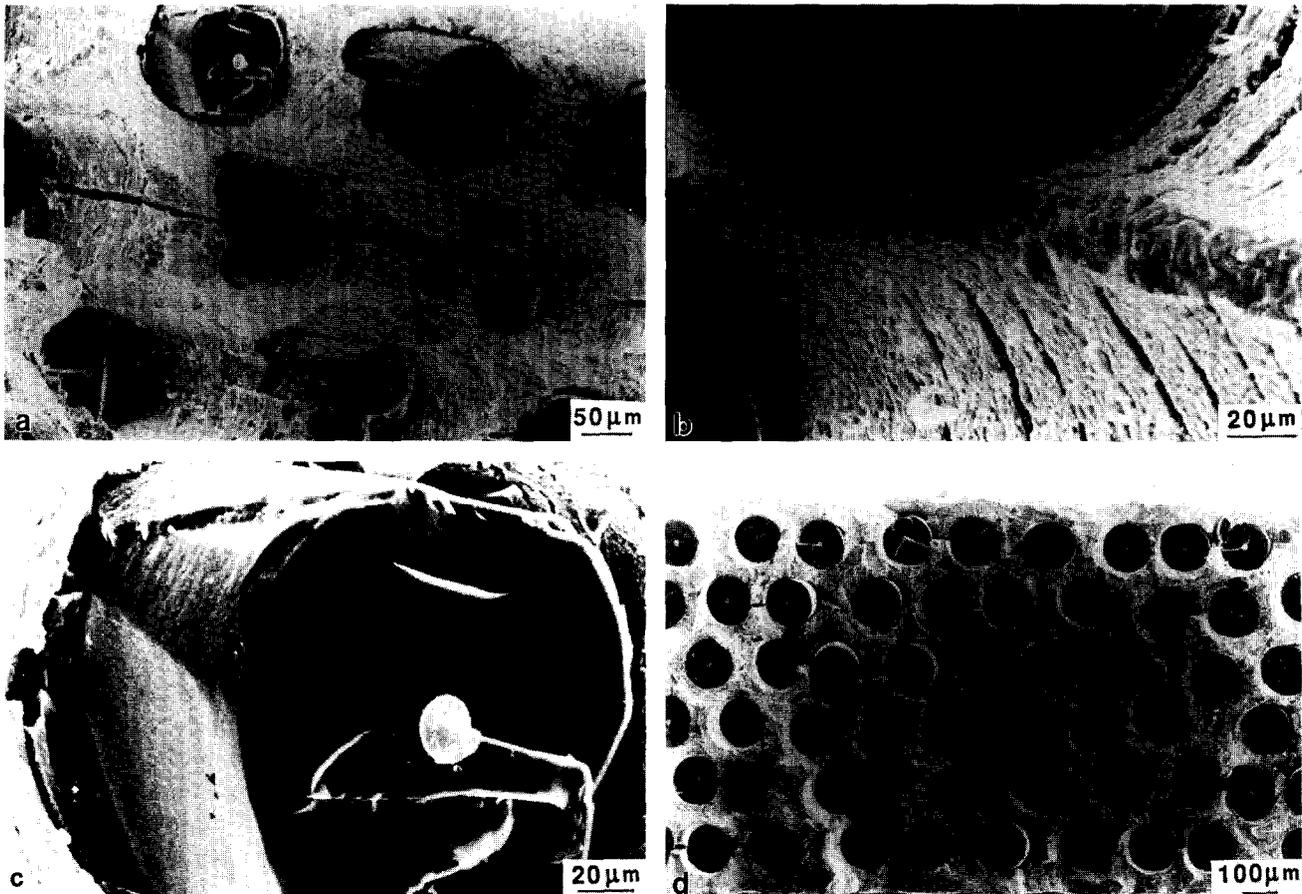
Fig. 15. SEM micrographs of the fracture surfaces: (a)–(c) post-shock reload, and (d) as-received Ti-6Al-4V/B₄C/B composites. The fibers were most often seen to separate from the matrix at the interface between the B₄C coating and reaction products in both the SP and AR samples, as shown in (b). But in SP sample interface splitting between the B and B₄C coating layer has also been observed occasionally, as seen in (c). The fracture surface of the AR sample (d) was seen to be much more planar and brittle.

It can be seen that the majority of the fibers, whether SP or AR composite, were separated from the matrix at the interface between the B₄C and reaction products (Fig. 15(b)) rather than from the reaction products and the Ti matrix. The brittle and chapped TiB₂ layer can be seen to debond from the fibers. A similar situation has been found in other Ti-base composites under quasi-static loading where the fracture path was close to the fiber side of the reaction zone [17]. In addition, splitting between the B and B₄C coating layer was also observed occasionally in the SP (but not in the AR) specimen; one example is shown in Fig. 15(c). Based on these observations, it is postulated that the reaction products do not form a strong bond with the B₄C coating layer, leading to interface splitting and further fiber pullout from this interface, especially for the SP specimens. Conversely, the outer needle-shaped TiB phase grows into the Ti matrix, resulting in relatively stronger bonding compared with the bond between the B₄C/TiB₂.

in splitting the fiber/matrix interface, since the force vector is now perpendicular to the fiber and the interface. Severe debonding and thus fiber pullout in the post-shock tension tests were frequently observed. The release wave also appeared to have acted on the interface between the diffusion-bonded plies of the Ti-base composite, since some delaminations were seen in this study (e.g., Fig. 15).
